Pacific Highway - Oxley Highway to Kundabung

This report outlines three prominent issues with civil construction site revegetation processes and how we were able to efficiently and cost effectively overcome them.

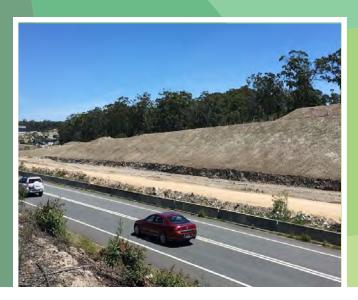
Figure 1 - Cut 5 NB Nov 2015, Failed Standard Specification Mix

Figure 1 and 2 above illustrates the difficulty in achieving a result with standard applications. These applications are still visible on the soil surface, yet following sufficient rain, have not germinated.

The site topsoil was deficient in calcium, nitrogen, phosphorus and potassium, with little organic content, resulting in poor microbe activity and nutrient cycling. Sitewon mulch was also mixed in with the topsoil, which would result in a nutrient draw-down, again not compensated for in a standard application.

Inorganic fertilisers and ameliorants were a necessity for these soils in order to stabilize the soil surface and promote healthy germination.

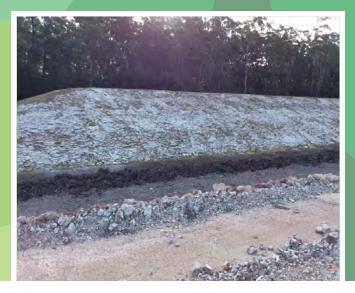
Figure 2 - Cut 5 NB Nov 2015, Failed Standard Specification Mix

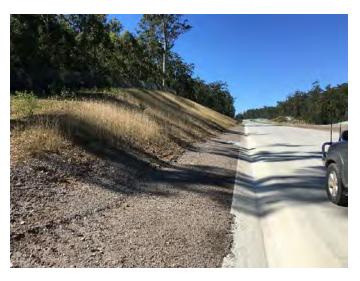
In areas where the annual crop did germinate, the annual grasses 'yellowed' and died off very quickly, due to the inefficient additives applied to the topsoil in the standard R178 application. Please see Figure 3.

This premature 'yellowing' of grasses can easily be noted on many highways and freeway revegetation projects. It is easily recognizable and relates to the lack of appropriate materials and ameliorants in the application. It is not suited to the site soil.

Figure 3 - Standard Hydromulch typical batter where initial cover crop germination has hayed off due to lack of long term nutrition.

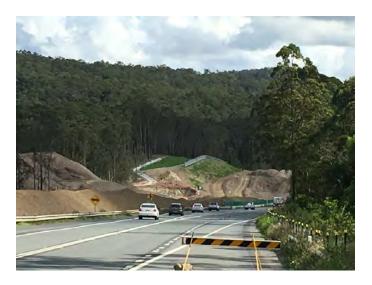
Figure 4 - Cut 19 NB Ameliorated Mix Application, Upper Batter 10th Oct 2015, Lower Batter 29th Oct 2015

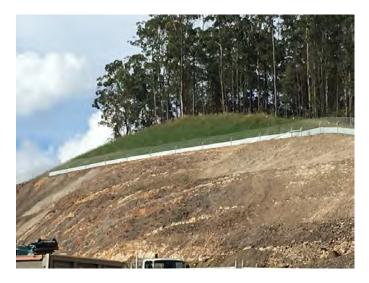
Figure 5 - Cut 19 NB Ameliorated Mix Application, Upper Batter 10th Oct 2015

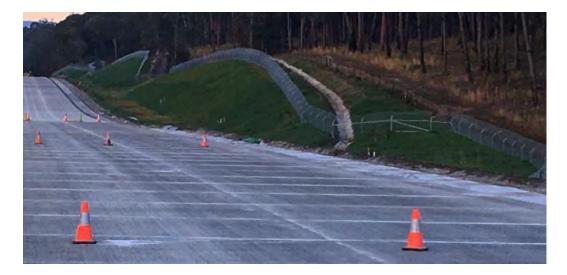
Figure 8 - Cut 2, 27th July 2016, Ameliorated Application Annual Grass Germination

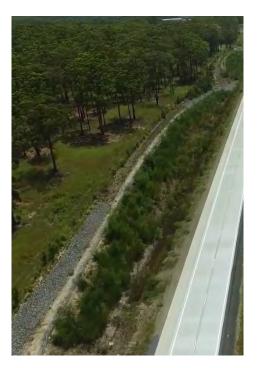
Figure 10 - Aerial Cut 2 Ameliorated Application Native Grasses and Shrub Germination

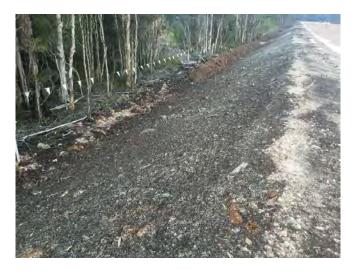
Due to the increased absorption rate of these materials in comparison to standard conventional hydromulch, our applications tend to successfully establish at a faster rate. Please see Figure 11 below.

Figure 11 - Fill 13 NB 16th Sept 2015 after Initial Rainfall -Application no longer visible on surface, allegedly washed down batter into wood chip berm

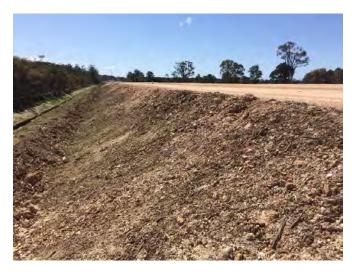
Within two weeks of the initial rainfall event, preliminary erosion control is being established via emerging grasses. It was clear that the fine particles had been absorbed into the soil surface in the rain events, propagating grass growth shortly thereafter. See figure 12 and 13 below.

Figure 12 - Fill 13 NB 29th Sept 2015 after 97.2 mm Rainfall since 16th Sept 2015 - Germination evident on face, more pronounced on topsoil areas.

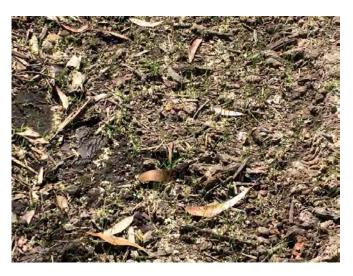
Figure 13 - Fill 13 NB 29th Sept 2015 after 97.2 mm Rainfall since 16th Sept 2015 - Germination on Flats

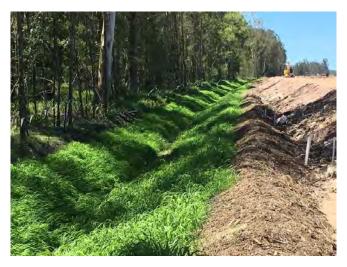
Figure 16 - Fill 13 NB Drain 10th Nov 2015 after 173.3 mm Rainfall since 29th Sept 2015 - Dense healthy grass on loose topsoil surface
