# WSA Early Earthworks Heavy Compost Blanket in lieu of Jute Mesh & Bitumen Emulsion in drains

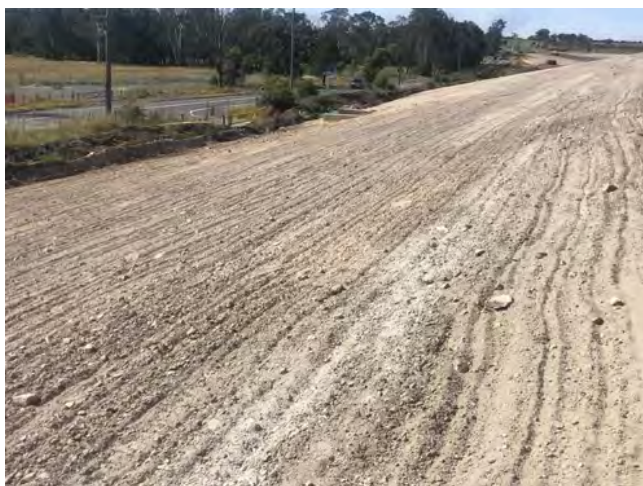
*Figure 1: Surface Preparation*

Surface preparation was completed using our batter chains and an excavator to create furrows in the subsoil, as the site lacked any topsoil. **See Figure 1.**

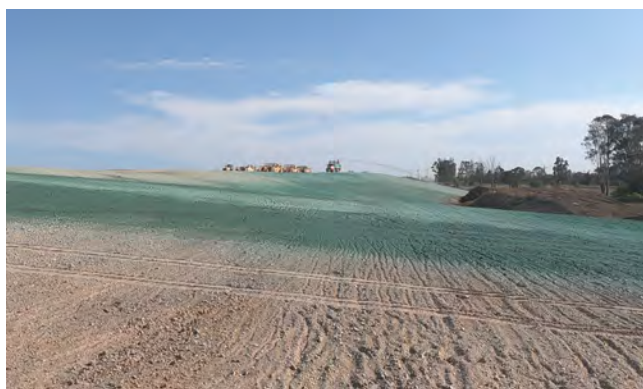
Initial Heavy Compost Blanket application to batter and invert of drains on subsoil – 18th November 2019. **See Figure 2.**

*Figure 2: Initial Application*

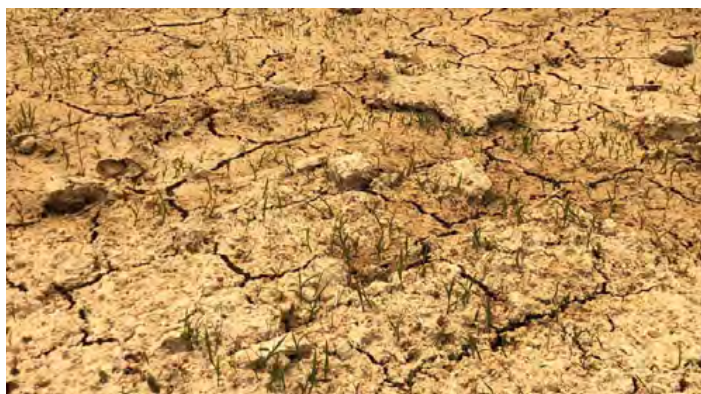
Enhanced image: 1 week later during extreme dry weather/ bush fires - 25th November 2019. **See Figure 3.** Total rainfall for this month was 10.6mm.

*Figure 3: Soil during drought conditions*

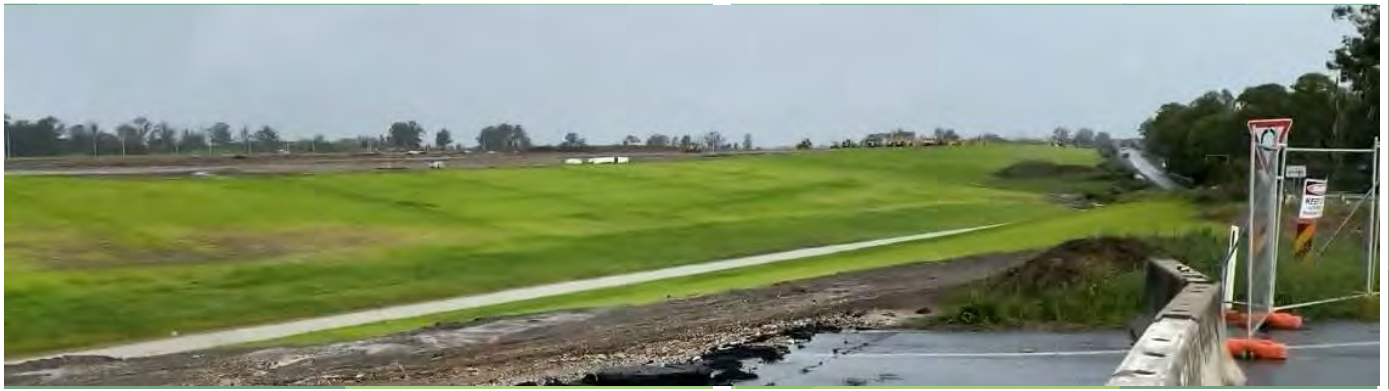
*Figure 6: Established annual grass coverage*

After receiving 428mm in early February, drain remains intact and stabilised with well-established annuals - 14th February 2020. **See Figure 6.**

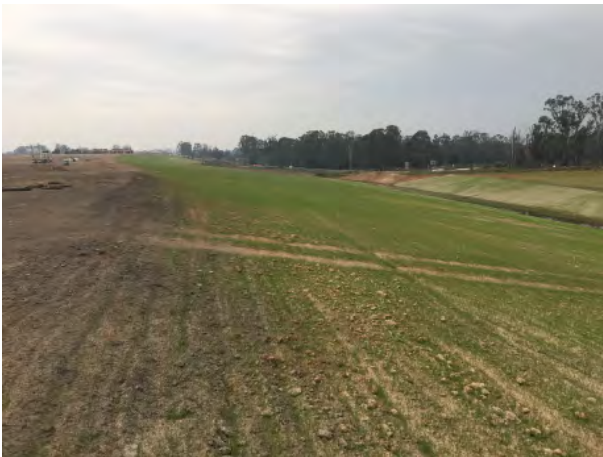
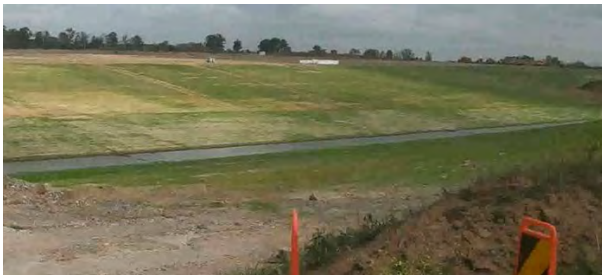
*Figure 4: Grass growth following initial rainfall*

*Figure 5: Grass growth following initial rainfall*

Following initial rain after drought, germination has begun - 24th January 2020. **See Figure 4 & 5.** Total rainfall this month was 71.4mm.
