Standard vs Ameliorated Application

Great Western Highway - Kelso to Ragland

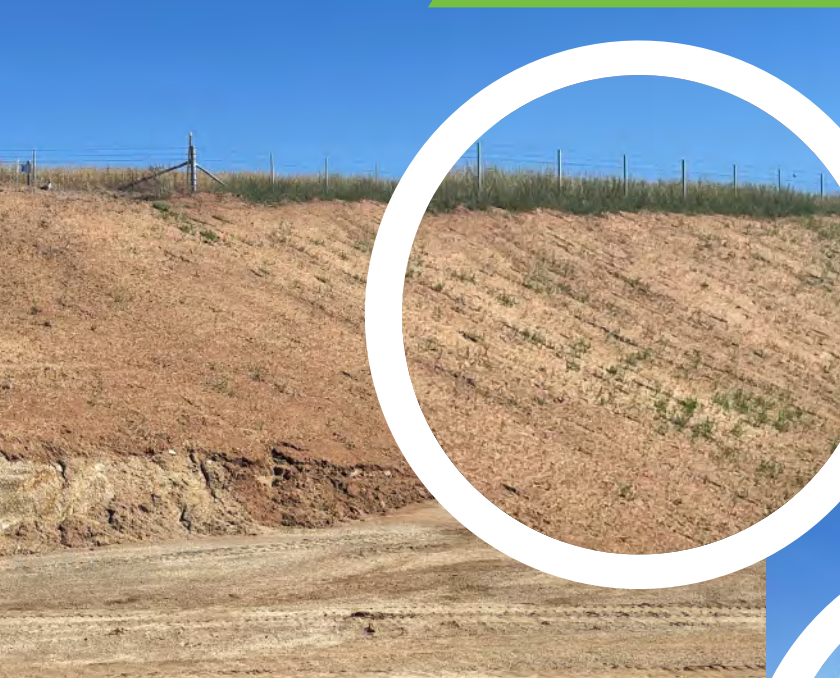
On this area we applied a Standard Hydromulch application, which failed because there was not enough nutrients in the soil to stabilise the seedbed and allow for germination. As you can see, the batter did not wash away and remained on the surface.

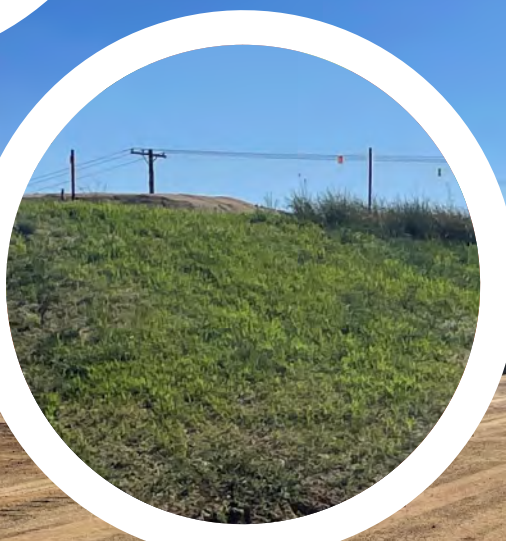
On another section, we applied a Light Compost Blanket. The results were much better and the client requested that the remaining areas be re-treated with this application.
